**Noosa Integrated Catchment
Association**

**Water Quality Monitoring
Annual Report
January-December 2025**

Noosa River Catchment of Southeast
Queensland

March 2026

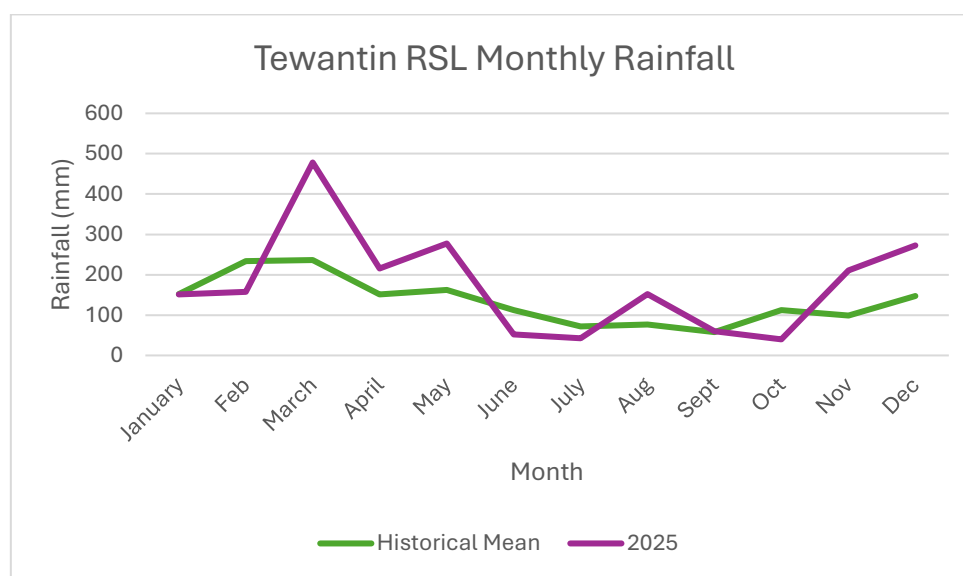
Figure 6: Monthly rainfall 2025 and historical averages for Tewantin RSL

To better understand water quality patterns, recent rainfall and tidal data were incorporated into the analysis. Rainfall records from the Bureau of Meteorology’s Tewantin RSL Park station show that 2025 received 2110.8 mm, and 2024 received 2300mm, both substantially higher than the long-term average of 1609.2 mm (1997–2026) (http://www.bom.gov.au/climate/averages/tables/cw_040908.shtml). Several heavy rainfall events (>70 mm in 24 hours) occurred early in the year and December, contributing to elevated turbidity, reduced dissolved oxygen, and increased organic and sediment loads across multiple sites. These hydrological conditions are important for interpreting the variability observed in the score cards that follow.

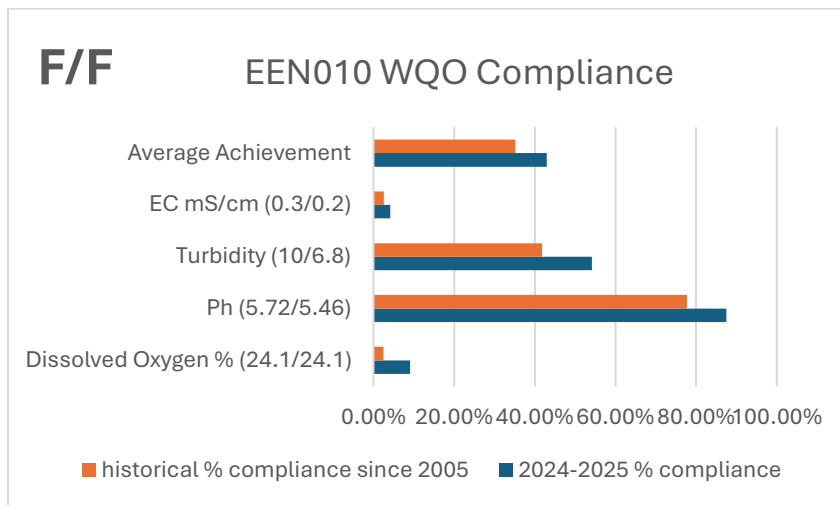
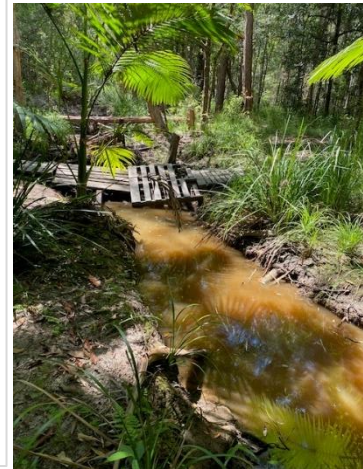
EEN010 continues to show severely degraded water quality, dominated by very low dissolved oxygen and acidic conditions. The site can have very low flow at dryer times of the year or month. Dissolved oxygen compliance is very poor, with a median level of 24% not supporting fish life. A makeshift bridge built by the community blocks the flow of the creek, contributing to the low dissolved oxygen compliance. Acid sulphate releases could explain the non-compliance with DO% and pH guidelines. These conditions are typical of acid sulphate soil drainage with high organic loads and limited reaeration.

Historically, this site has had an F grade, and the two-year average achievement is indicating little improvement over time. Here is has been analysed under HEV/SD Northern Noosa Fresh Waters; Southern Noosa Fresh Waters EVZ, although 2010 guidelines have been used in the past. While the guideline may not perfectly reflect the natural chemistry of this drain, the extremely low DO% clearly indicates ecological stress. A locally revised WQO is appropriate, but so too is targeted management of this area.

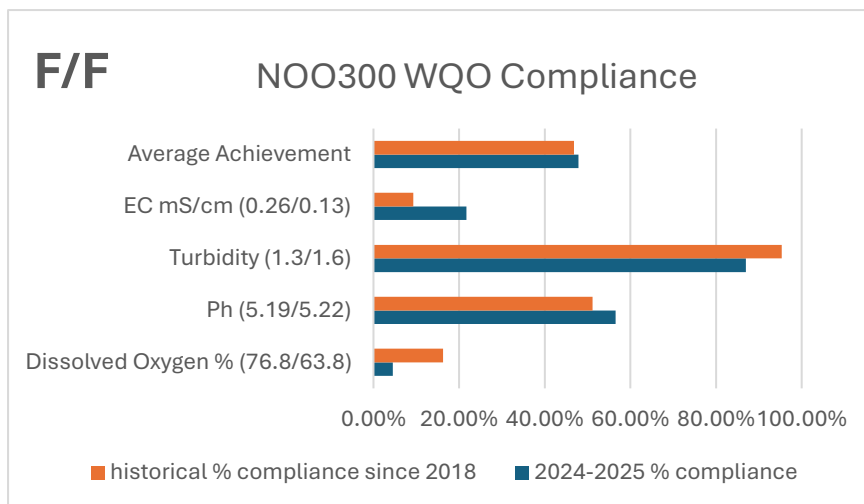
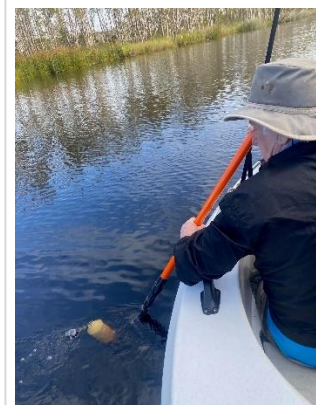
At NOO300, dissolved oxygen and EC are the main limiting parameters, with DO% frequently below guideline ranges. The two-year compliance shows relatively good turbidity performance (87%) but low DO% and EC compliance, giving an overall average achievement of about 48%, which is similar to the historical value. This suggests persistent low-oxygen, low-pH conditions upstream of Lake Como. Low EC compliance may be due to some salinity influence.

The site's F grade reflects continuing oxygen stress and acidity, likely influenced by upstream wetlands, acid sulphate soils, and organic matter inputs.

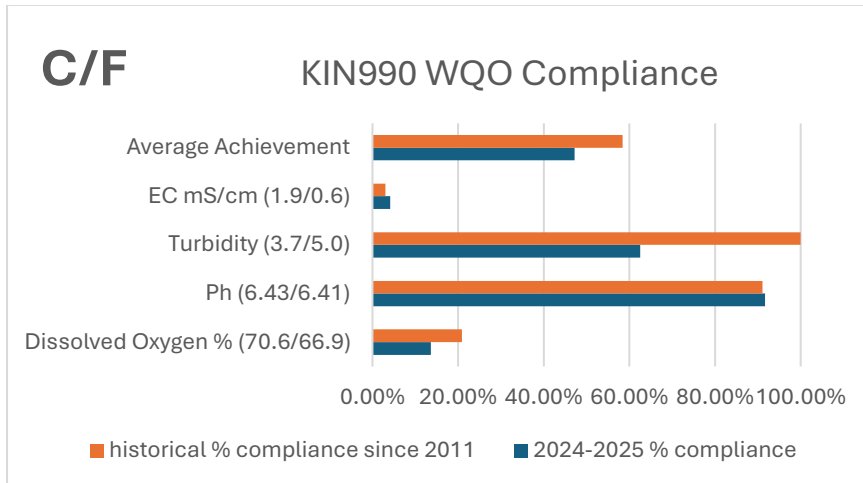
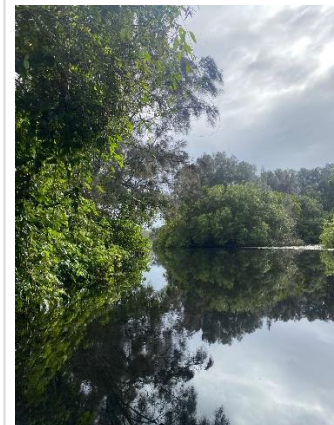
KIN990 shows mixed performance, with strong pH and turbidity compliance but weaker dissolved oxygen and EC results. The two-year average achievement of 47% is lower than the historical average of 58%, indicating some decline in overall compliance during the recent wetter period. EC compliance can be very low due to some tidal saltwater influence which complicates interpretation of conductivity against freshwater guidelines.

Despite good pH and turbidity, low DO% remains a concern, particularly during periods of high organic loading and reduced mixing. The C/F grading reflects this tension between generally good physical clarity and problematic oxygen conditions, but is not accurate grades due to the salinity influence on EC. Continued monitoring is important to distinguish between natural variability (including tidal influence) and emerging catchment pressures such as land use change and erosion.

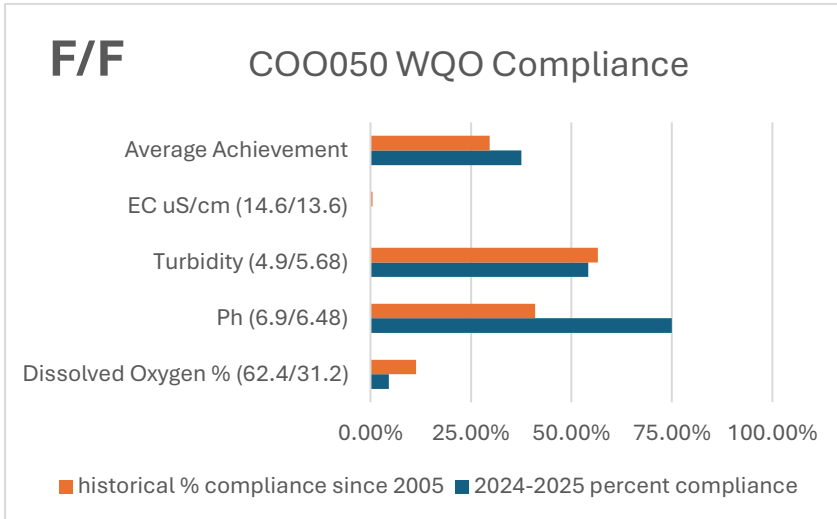
COO050 continues to perform poorly overall, with dissolved oxygen the key limiting factor. The two-year average achievement 38% is slightly higher than the long-term value, but DO% compliance remains very low at 5%, indicating persistent oxygen stress. pH and turbidity show moderate compliance, while EC is almost never within guideline ranges, reflecting the tidal saltwater influence which complicates interpretation of conductivity against freshwater guidelines. Therefore this site’s grade is not accurate.

High rainfall in early 2025 likely exacerbated oxygen depletion through increased organic loading. The F grade is consistent with a low-gradient, tannin-rich creek where natural conditions may already be marginal for DO%, but the current levels are still concerning for aquatic life. This site would benefit from local WQOs that better reflect natural brackish conditions, alongside catchment actions to reduce fine sediment and organic inputs.

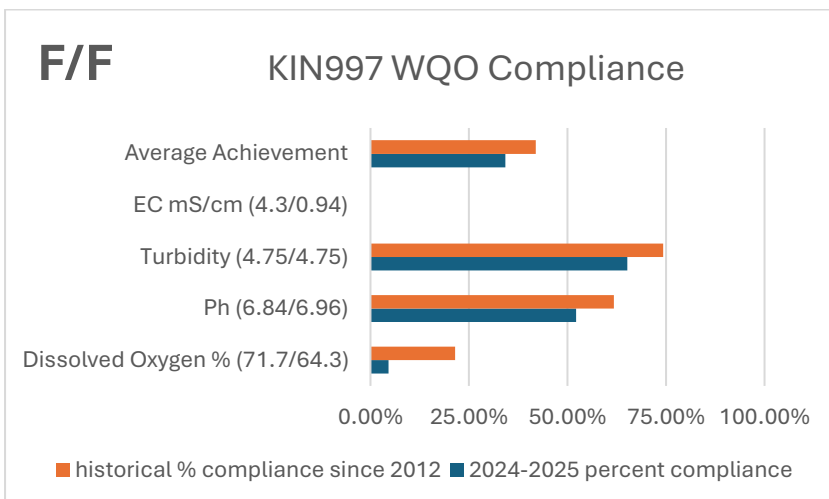
KIN997 shows consistently poor performance for dissolved oxygen and EC, with only moderate compliance for pH and turbidity. The two-year average achievement 34% is lower than the historical average 42%, suggesting a decline in recent years, likely linked to wetter conditions and increased organic loading. DO% compliance is particularly low indicating frequent oxygen stress, while EC is almost never within guideline ranges, reflecting the tidal saltwater influence which complicates interpretation of conductivity against freshwater guidelines.

The F grade is inaccurate due to the EC non-compliance, but otherwise reflects a system with limited buffering capacity and saltwater influence, where acidity and low DO% are persistent features. Continued monitoring and refinement of local WQOs will help distinguish natural background conditions.

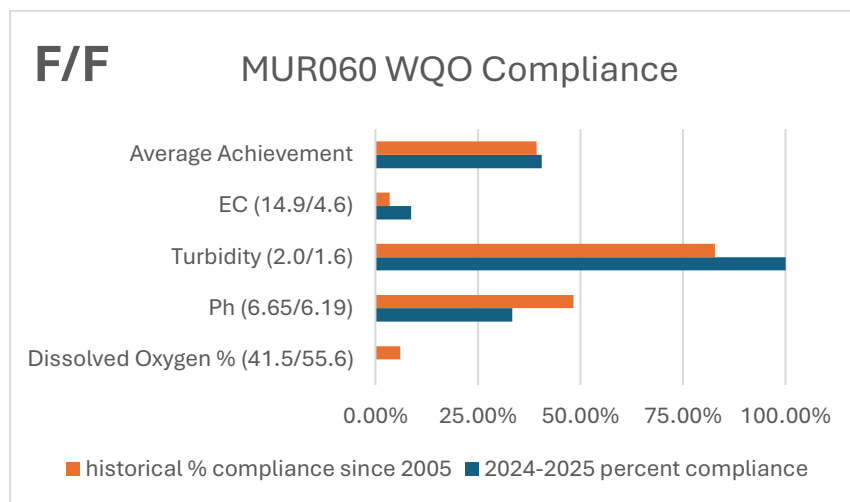
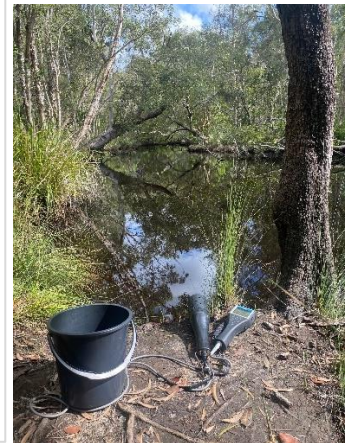
MUR060 remains a low graded site, with very low dissolved oxygen and pH compliance. The two-year average achievement 41% is similar to the long-term value, indicating persistent issues rather than short-term anomalies. Turbidity compliance is 100% suggesting that clarity is not the primary concern, while EC is low because of salt water tidal influence.

The F grade is driven by chronic oxygen and pH non-compliance, likely linked to acid sulphate soils, Wallum areas upstream, organic-rich sediments, and low gradient flow. High rainfall events in early 2025 would have mobilised additional organic matter, further depressing DO%.

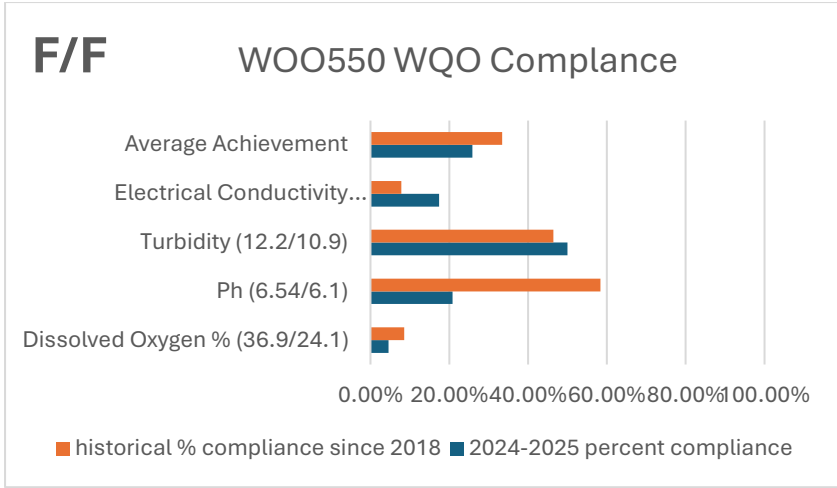
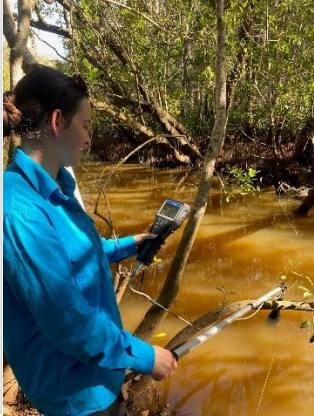
WOO550 shows very poor dissolved oxygen and pH compliance, with turbidity frequently elevated during wet periods. The two-year average achievement 26% is lower than the historical value 33%, indicating a deterioration in recent years. The site often notes visibly murky water with low flow and stagnation. Rainfall-driven erosion and organic loading is apparent and a change from HEV to Moderately Disturbed (MD) WQO is more applicable. Low flow WQOs should possibly be used to analyse this site despite rainfall records.

EC remains low, consistent with tidal influenced creek, not freshwater. The F grade highlights stress and anthropogenic influence, particularly during high-flow events when sediments and organic matter are flushed through the system. This site is a priority for investigating upstream sediment sources, bank stability, and potential urban runoff contributions.

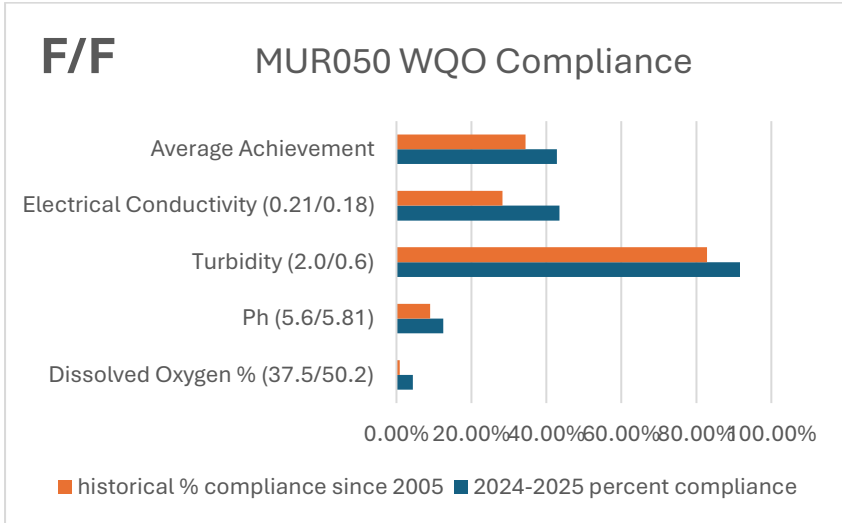
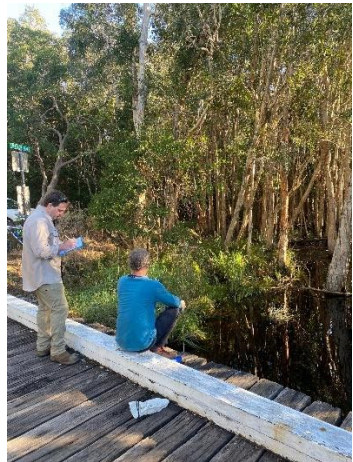
At MUR050, dissolved oxygen and pH are the main drivers of 'poor' performance, while turbidity compliance is high. The two-year average achievement 43% is higher than the long-term value 34%, suggesting some recent improvement, particularly in EC and turbidity. However, DO% remains very low 4%, indicating ongoing oxygen stress.

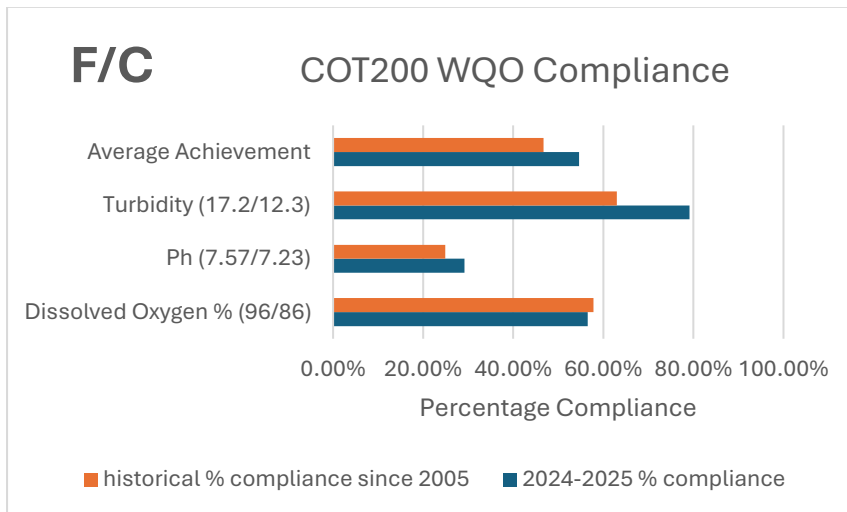
COT200 shows mixed performance, with relatively good turbidity compliance but weaker pH and dissolved oxygen results. The two-year average achievement of 55% is slightly higher than the long-term value 47%, suggesting improvement in recent years. DO% compliance is 57%, with a median reading of 96 DO%, one of the highest of all the sites but pH compliance remains low 29%, suggesting inaccuracies in the guideline.

The F/C grading reflects this variability: the site can meet guidelines under stable conditions but is sensitive to high-rainfall events and organic inputs. As an upper estuary location, it is influenced by both freshwater inflows and lake dynamics, which can affect mixing and oxygen levels. Ongoing monitoring will clarify whether the recent improvement is part of a positive trend.

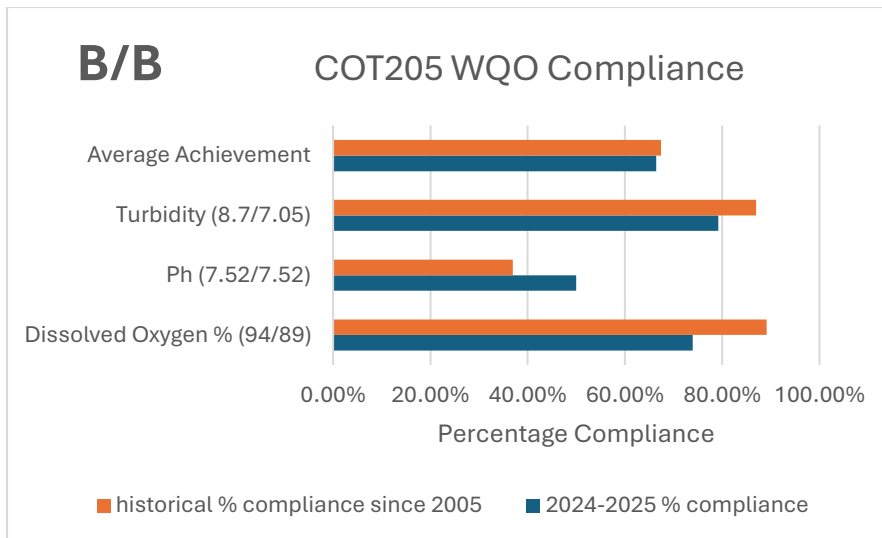
COT205 continues to perform well, with strong compliance for dissolved oxygen and turbidity and moderate pH compliance. The two-year average achievement closely matches the long-term value indicating a stable, resilient system. DO% compliance is high at 74%, and turbidity remains within guideline ranges most of the time.

The B/B grade reflects a healthy, well-mixed lake environment with good ecological condition. Seasonal changes in rainfall and temperature are evident but do not significantly compromise water quality. This site remains an important reference for upper estuary and lake health in the Noosa system.

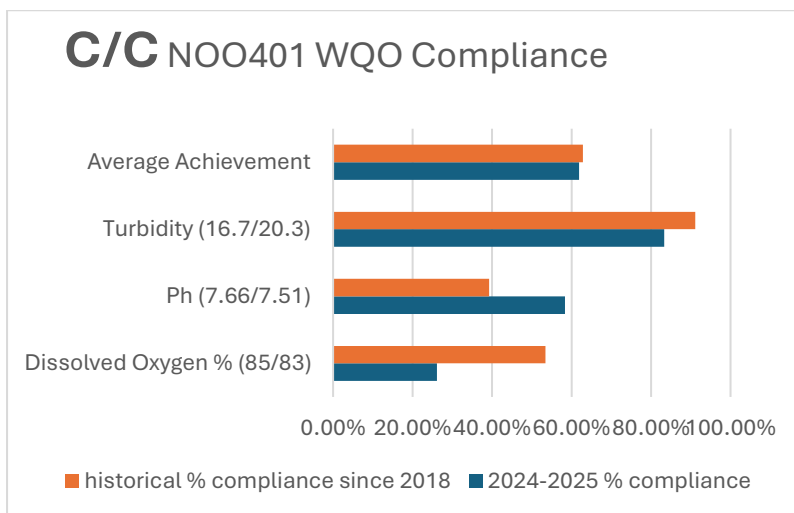
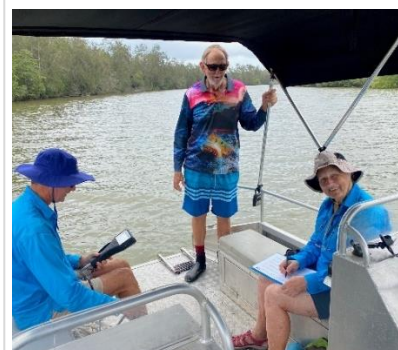
NOO401 shows generally good turbidity and pH compliance but more variable dissolved oxygen performance. The two-year average achievement of 62% is very similar to the historical value, indicating stable conditions over time. DO% compliance has decreased compared to earlier years, while turbidity remains high-compliance, reflecting good clarity but occasional oxygen stress.

The C grade suggests that while water quality is generally acceptable, there are periods of reduced oxygenation, particularly during calm, warm conditions. Minimising organic inputs will be important for sustaining current condition.

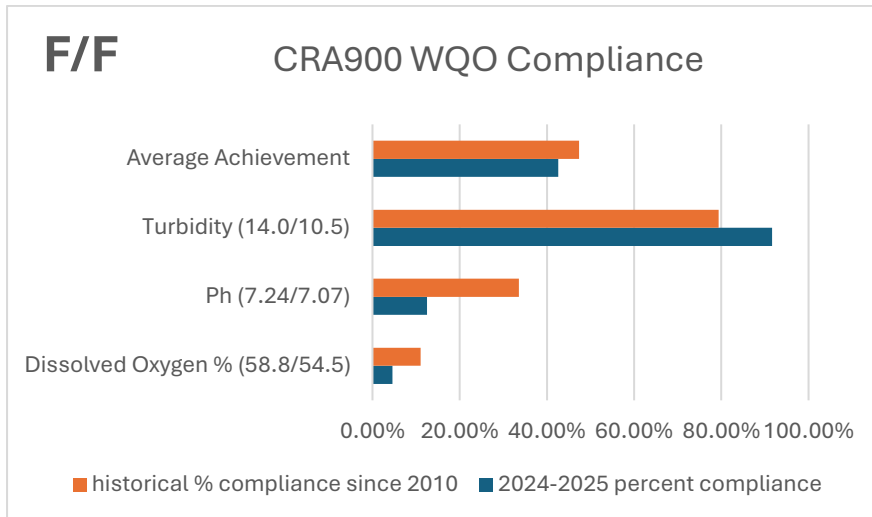
CRA900 continues to show poor overall performance, with dissolved oxygen and pH the main limiting parameters. The two-year average achievement 43% is slightly lower than the historical value. Turbidity compliance is high at 92%, suggesting that clarity is generally good. DO% compliance is very low at 5%, with a median of 58% DO, although fish are often seen at this site, so potentially the guidelines need amendment here.

The F grade may not be representative of the health of the creek, although it does have high influence from the surrounding area. As an estuarine creek, CRA900 is likely sensitive to local runoff, organic inputs, and limited mixing. Management should focus on reducing organic and nutrient loads and protecting riparian vegetation to improve shading and habitat complexity.

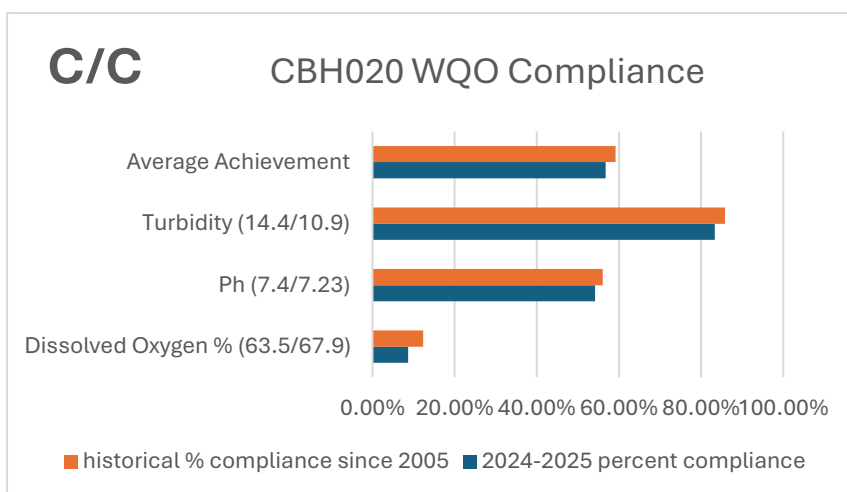
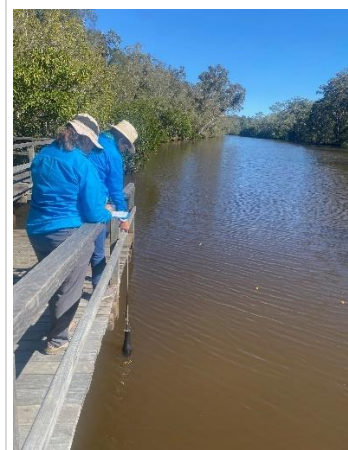
CBH020 shows moderate to good performance, with strong turbidity compliance and reasonable pH, but weaker dissolved oxygen. The two-year average achievement suggests stable conditions. DO% compliance remains relatively low with a median measurement of 67%DO, indicating periodic oxygen stress, particularly during warm, low-flow periods.

The C grade reflects this balance: good clarity and pH, but DO% that does not consistently meet HEV guidelines. As a creek entering Lake Cooroibah, CBH020 is influenced by both catchment runoff and lake water levels. Continued monitoring will help identify whether targeted riparian or flow management could improve oxygen conditions.

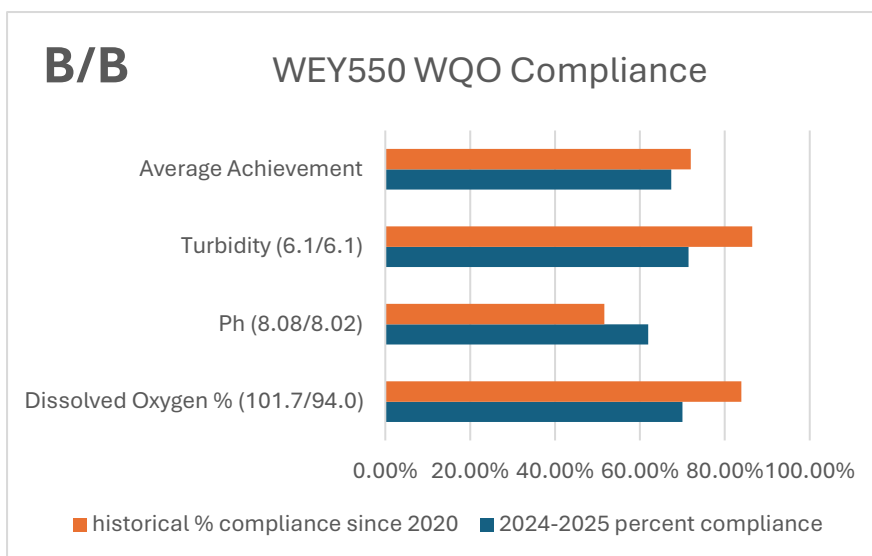
WEY550 performs well overall, with strong compliance for dissolved oxygen, pH, and turbidity. The two-year average achievement is slightly lower than the historical value, but still firmly within the B range. DO% compliance is high, and turbidity remains low, reflecting a well-flushed, high-value estuarine system.

The B grade indicates good ecological condition with only minor departures from HEV guidelines. Seasonal rainfall and tidal dynamics drive natural variability, but there is no clear evidence of long-term decline. Protecting surrounding mangroves and limiting urban runoff will be important to maintain this status.

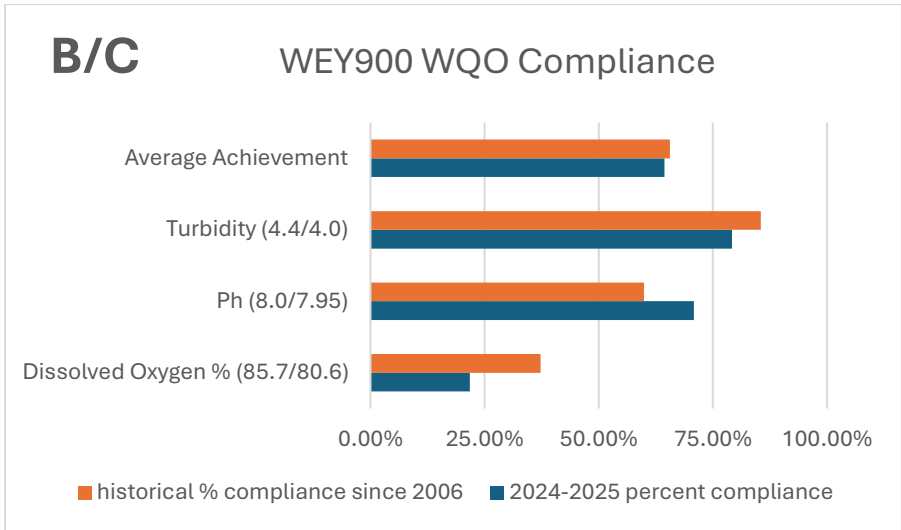
WEY900 shows good pH and turbidity compliance but more variable dissolved oxygen. The two-year average achievement is slightly lower than the long-term value. DO% compliance has dropped from 85 to 80% DO, suggesting more frequent low-oxygen events, possibly linked to organic loading or reduced mixing in this more sheltered location. Although a revised guideline may be appropriate here.

Overall WEY900 has generally good water quality, but with emerging oxygen concerns. As a mid-estuary site, WEY900 is sensitive to both catchment inputs and estuarine circulation. Ongoing monitoring will help determine whether this is a short-term response to recent wet years or a longer-term trend.

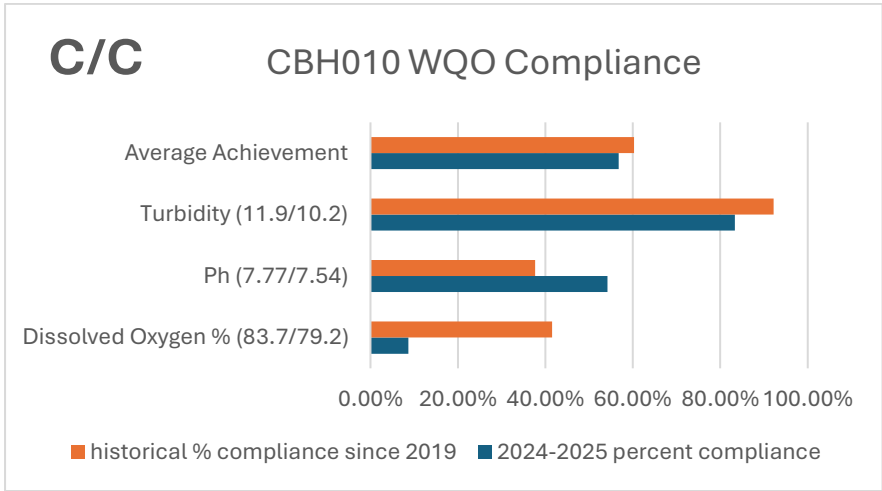
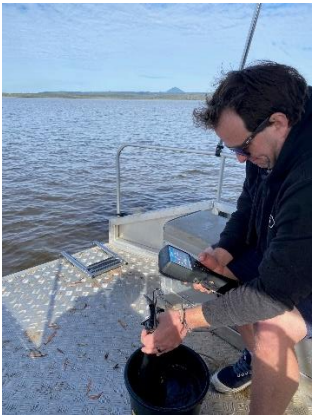
CBH010 shows moderate performance, with strong turbidity compliance but weaker dissolved oxygen and pH compliance. The two-year average achievement is slightly lower than the historical value, reflective of the higher rainfall. DO% compliance is very low for 2024-25, but still with a median of 79%DO. A revision of the guideline her is necessary.

Cooroibah is sensitive to sediment stirring up from the lakebed and organic loading from upstream. Maintaining riparian vegetation and minimising nutrient inputs will help reduce the risk of further oxygen decline.

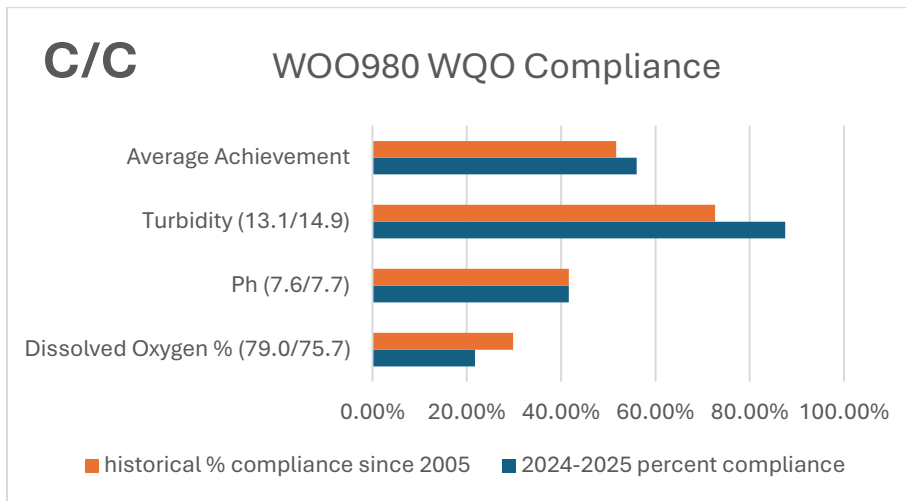
WOO980 shows moderate to good performance, with strong turbidity compliance and reasonable pH, but variable dissolved oxygen. The two-year average achievement is only slightly higher than the historical value. DO% compliance 22% remains low, indicating that oxygen stress still occurs, particularly during low-flow conditions, although median measurement of 75-79%DO suggest an amendment to the guidelines.

The C grade reflects a transitional zone where creek water mixes with estuarine water, leading to variable conditions. Improvements may be linked to better flushing or upstream management, but the site remains sensitive to high-rainfall events and organic inputs. Continued monitoring will help confirm whether the recent improvement is sustained.

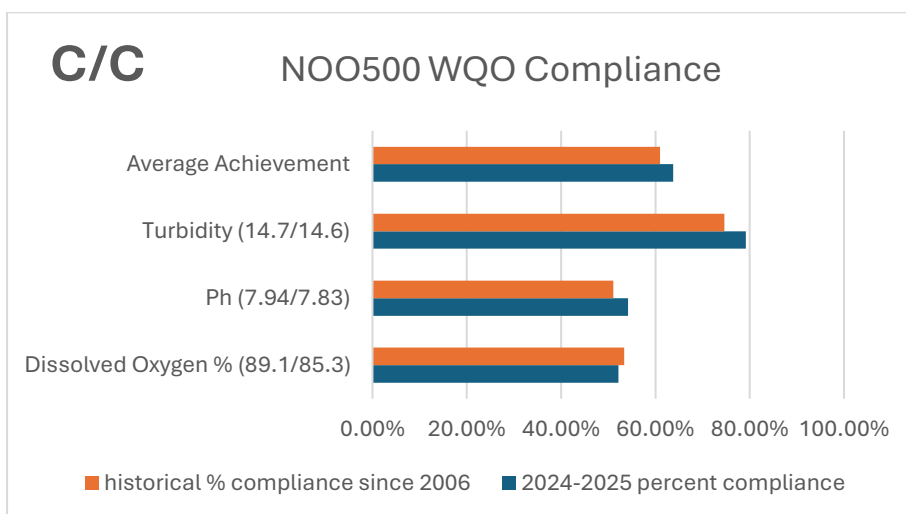
NOO500 shows generally good turbidity and pH compliance, with moderate dissolved oxygen performance. DO% compliance is reasonable, but medians of 85-89%DO

The C grade reflects a healthy but dynamic mid-estuary environment, where tidal mixing and freshwater inflows interact. While conditions are generally good, occasional low-oxygen events may occur during calm or high-temperature periods. Protecting surrounding mangroves and limiting nutrient inputs will help maintain current condition.

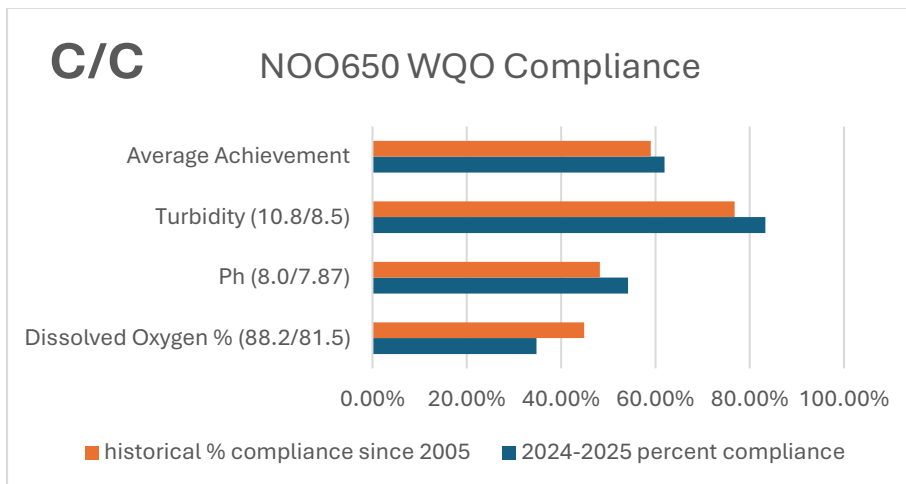
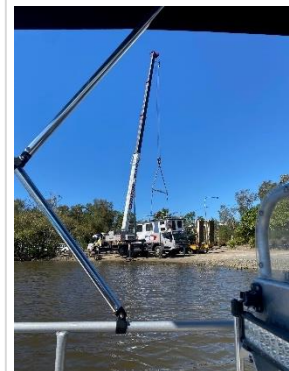
NOO650 performs moderately well, with strong turbidity compliance and reasonable pH, but variable dissolved oxygen. The two-year average achievement is slightly higher than the historically. DO% compliance indicates some periods of low oxygen, although the median recordings are 81-88%DO suggesting locally relevant guidelines could change the compliance.

Readings for this site are taken at the outflow from Lake Doonella, (under the Tewantin bridge near the marina) which may affect readings. While overall water quality is acceptable, ongoing monitoring is important to detect any emerging oxygen decline or high sediment loads. Maintaining vegetated buffers and managing urban runoff around the lake will be critical.

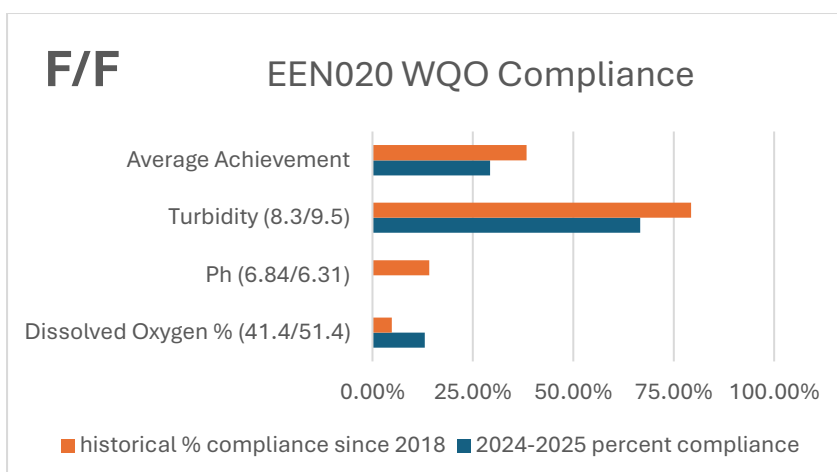
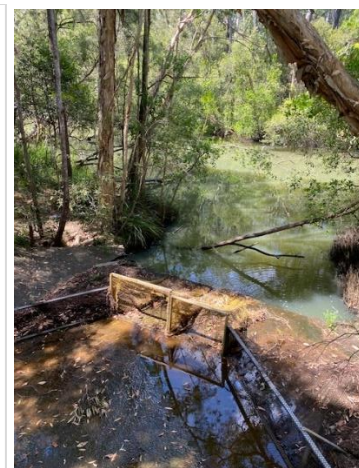
EEN020 shows poor overall performance, with very low pH and dissolved oxygen compliance. These results indicate a high level of freshwater influence or potentially acid sulphate releases. Dissolved oxygen compliance is very poor, with a median level of 51% DO which has improved in 2024–25 from 41% historically. The two-year average achievement of 29% is lower than the historical value 38% indicating a reasonable decline in compliance.

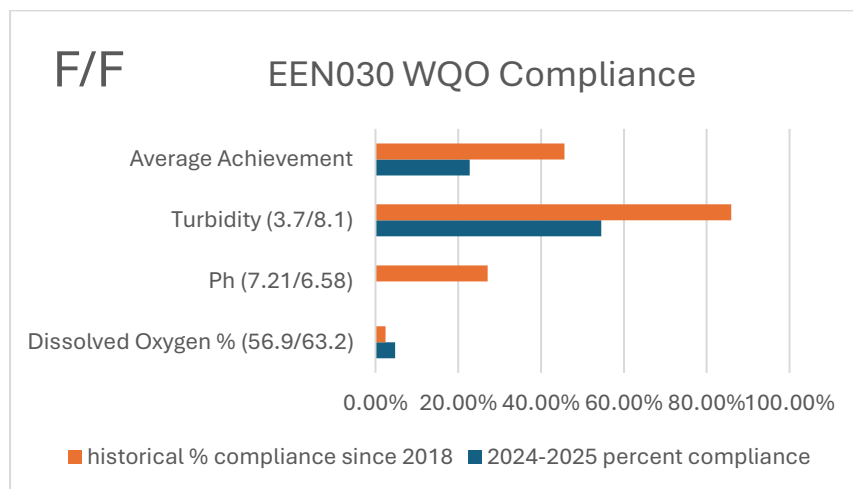
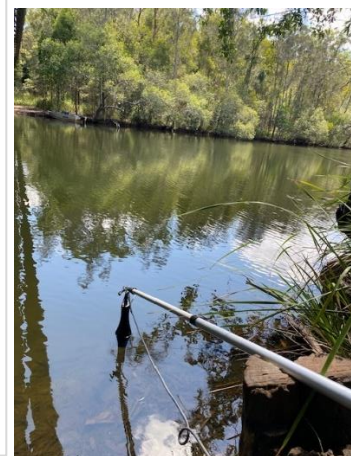
EEN030 (downstream from EEN020) also performs poorly, with very low pH and dissolved oxygen compliance and only moderate turbidity performance. The two-year average achievement of 23% is much lower than the historical value 46%, indicating a significant decline in recent years. DO% compliance remains very low with medians of 57-63% DO, and pH is frequently below guideline ranges.

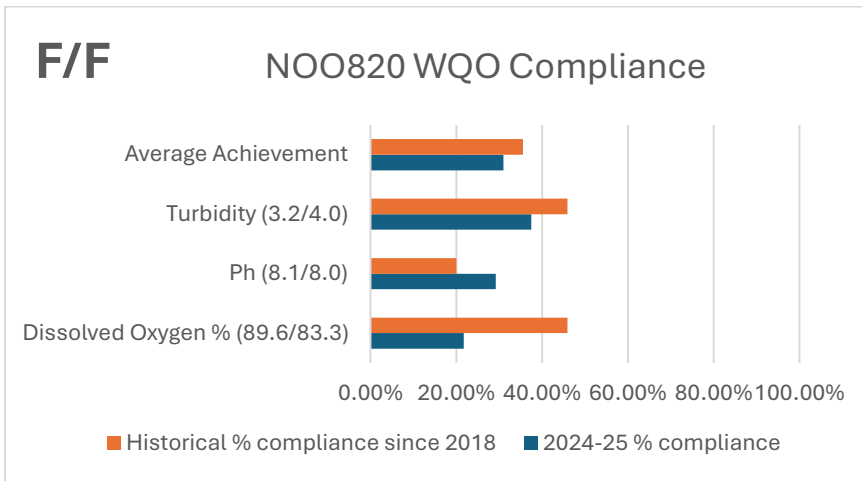
NOO820 shows surprisingly low overall compliance for a lower estuary HEV site, with moderate DO% but poor pH and turbidity performance. The two-year average achievement of 31% is slightly lower than the historical value. DO% compliance is very low although median readings are between 83-89% DO. Turbidity often exceeds the very tight HEV guideline range, again suggesting locally relevant guidelines are required here.

The F grade doesn't seem accurately reflective of the site, instead likely reflects the stringency of the lower estuary WQOs as much as actual ecological condition. As a highly dynamic tidal site, NOO820 experiences strong mixing, boat traffic, and variable sediment resuspension. While guideline compliance is low, the system may still function well ecologically; local WQO refinement would help contextualise these results.

The lower estuary sites (NOO820 and TNC01) again recorded low compliance, but this appears to reflect the stringency of the HEV guideline values rather than poor ecological condition. Turbidity guidelines are extremely tight for these dynamic, high-energy environments, where natural sediment resuspension is common. These results highlight the need for revised local WQOs that better represent natural variability in the lower estuary.

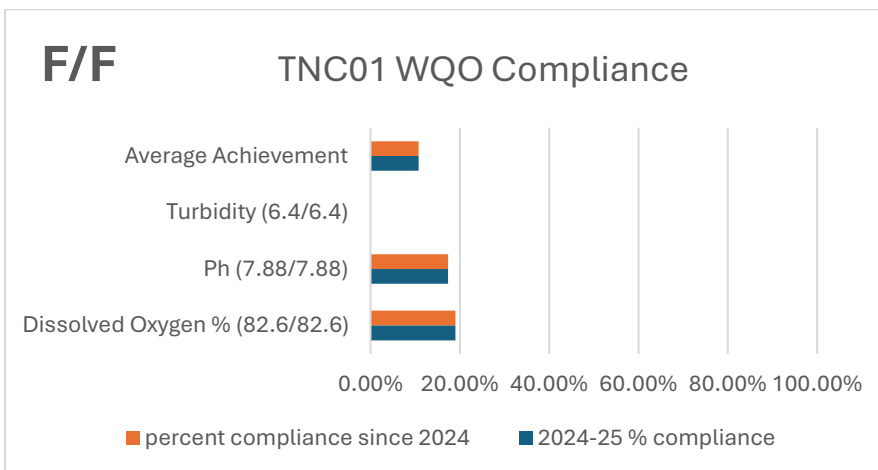
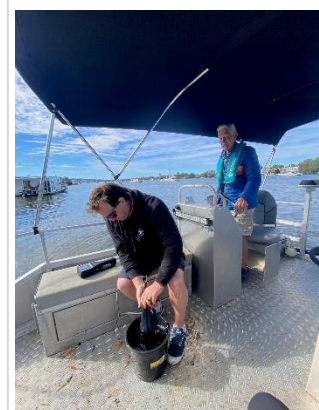
TNC01 shows very low overall compliance, driven mainly by turbidity exceeding the very tight HEV lower estuary guideline. The two-year (and historical) average achievement is only about 11%, with DO% and pH compliance very low. Turbidity compliance is effectively zero, reflecting frequent resuspension in this shallow, high-energy environment near the oyster reefs.

The F grade highlights the mismatch between guideline expectations and the natural dynamics of an oyster-bed, sandbank-dominated channel. While water quality rarely meets the WQOs, this does not necessarily indicate poor ecological condition. This site is a strong candidate for locally derived WQOs that better reflect natural turbidity regimes and habitat function.

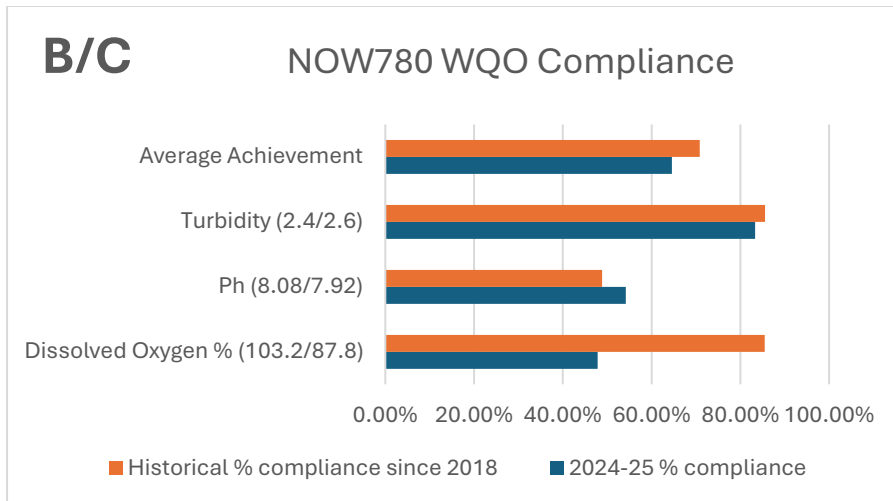
NOW780 shows generally good performance, with strong turbidity and pH compliance and moderate dissolved oxygen. The two-year average achievement of 65% is slightly lower than the historical value. DO% compliance suggests occasional low-oxygen events, likely during warm, low-flow periods, although medians still sit between 103 and 87% DO.

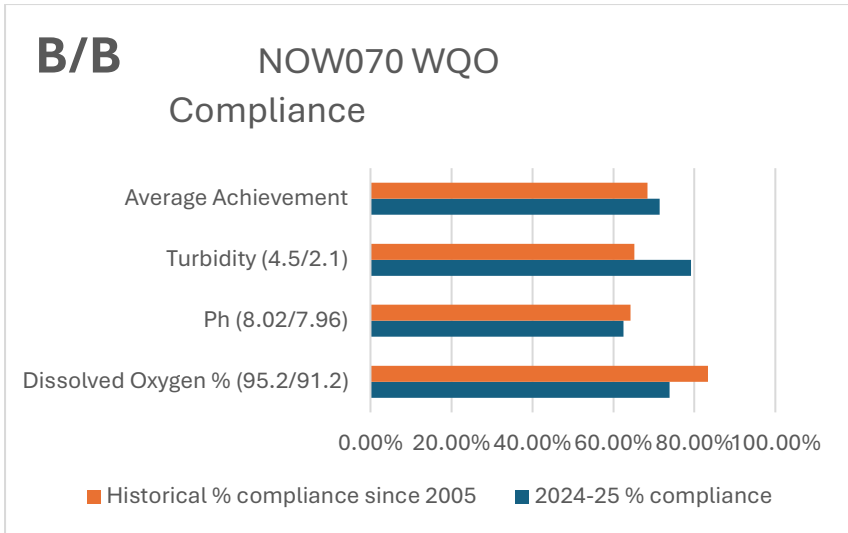
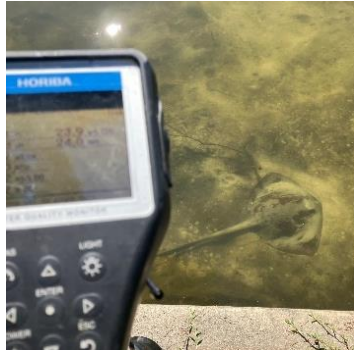
NOW070 performs well, with strong compliance for dissolved oxygen, pH, and turbidity. The two-year average achievement 71% is similar to the long-term value, indicating stable, good-quality conditions. DO% compliance is high with median reading for 2024-25 at 91% DO, and turbidity remains low, reflecting effective flushing and mixing at the canal outflow.

The B/B grade indicates a well-functioning canal reach that generally meets MD WQOs. Continued attention to stormwater management and canal maintenance will help sustain this condition. This site can serve as a useful benchmark for other canal locations in the system.

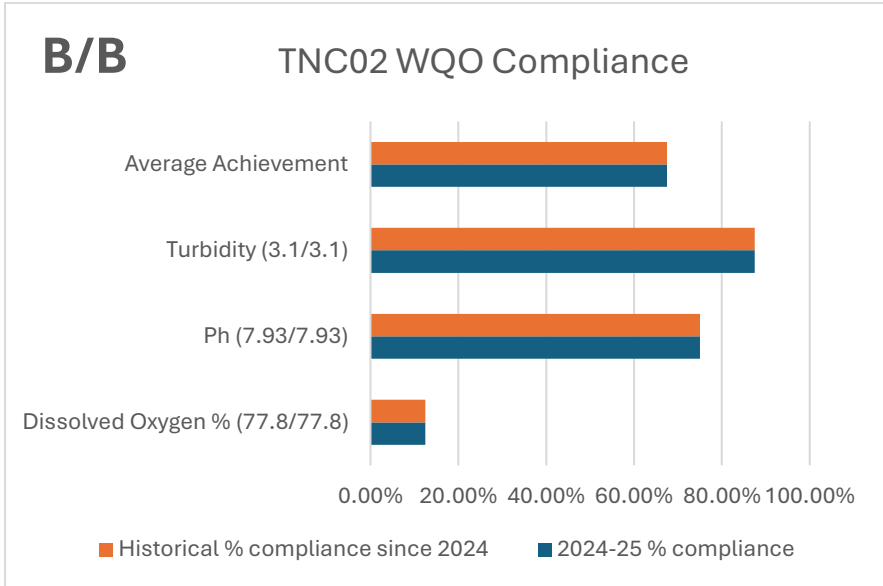
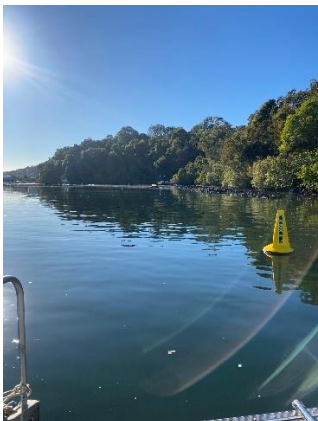
TNC02 shows good overall performance, with strong pH and turbidity compliance and moderate dissolved oxygen. This site only has 2 years of data, so can't be compared to longer term historical records. DO% compliance is lower than other parameters, suggesting occasional low-oxygen events and suggests a revision to guidelines.

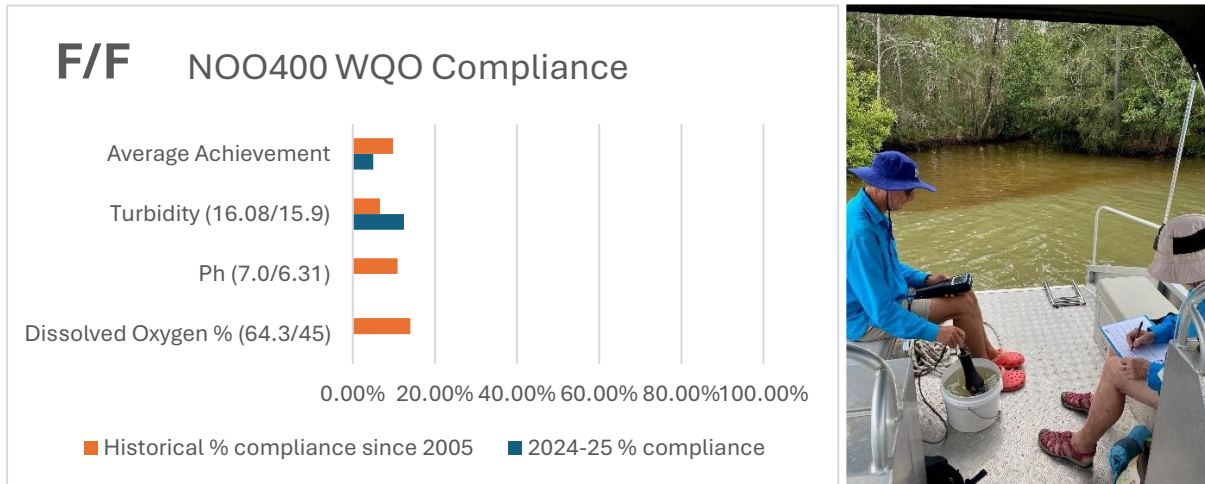
NOO400 is one of the poorest-performing canal sites as it is an unmanaged man-made canal upstream near Lake Cootharaba and NOO401. Water runoff is always visibly murky and dark, and little is known about the catchment as it is on private land. Dissolved oxygen % has decreased from a median of 64% historically to 45% at this site over 2024-25. Turbidity has increased and pH has also decreased from 7.0 to 6.31.
